2014

# Rockford Water Utility Annual Report

5/11/2015

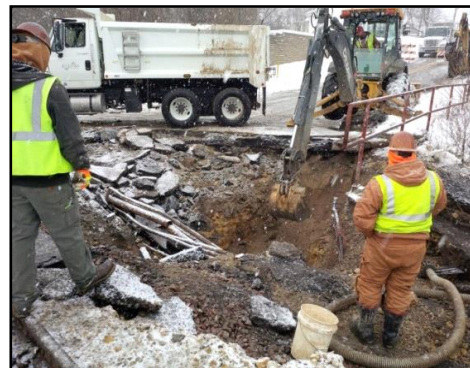
The number of service leaks and main breaks continues to rise as the water system ages (see picture). Service leaks in 2013 and 2014 were 721 and 723, respectively. This is up 30% from 2010 levels (555). Main breaks have increased by 22% over the last 15 years; from an average of 90 to 110 per year. During this time, staffing levels have remained the same. The increase in emergency repairs (service leaks and main breaks) have required management to divert resources away from preventative maintenance programs such as valve exercising, leak locating, hydrant maintenance and fireflow testing. The effects of reduced preventative maintenance programs are apparent; particularly with respect to the increases in water loss over the last three years.
